## coloQuick Pasteur

# INVERT Z-POSITION SIGNAL

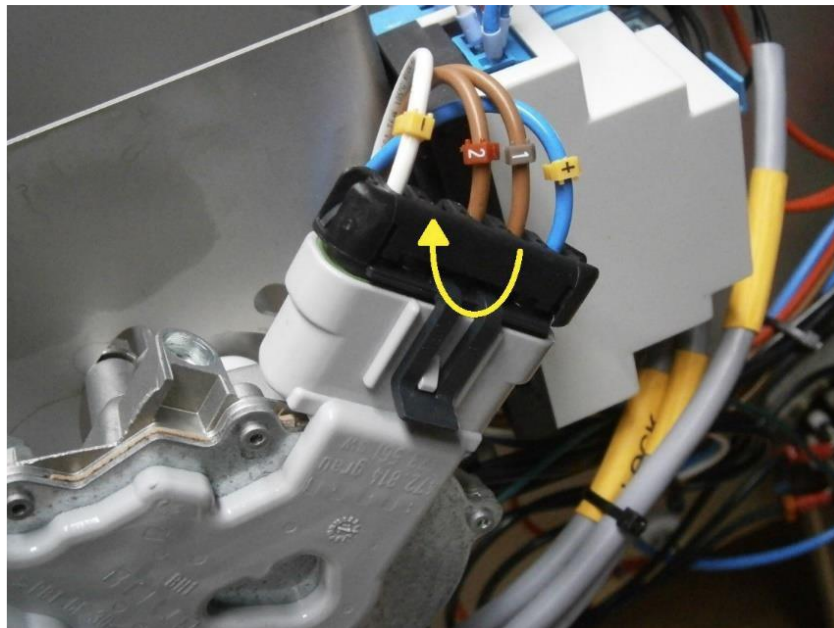
The reason is that the Z-position (Motor-stop) signal are inverted from NC to NO, to prevent the motor from stopping in random positions.

The picture below shows the wiring on the motor plug, before moving the wire:

The brown wire, located at the second terminal from the right, must be moved to second terminal from the left (which is now unused).
