ColoQuick Pasteur

INVERT Z-POSITION SIGNAL

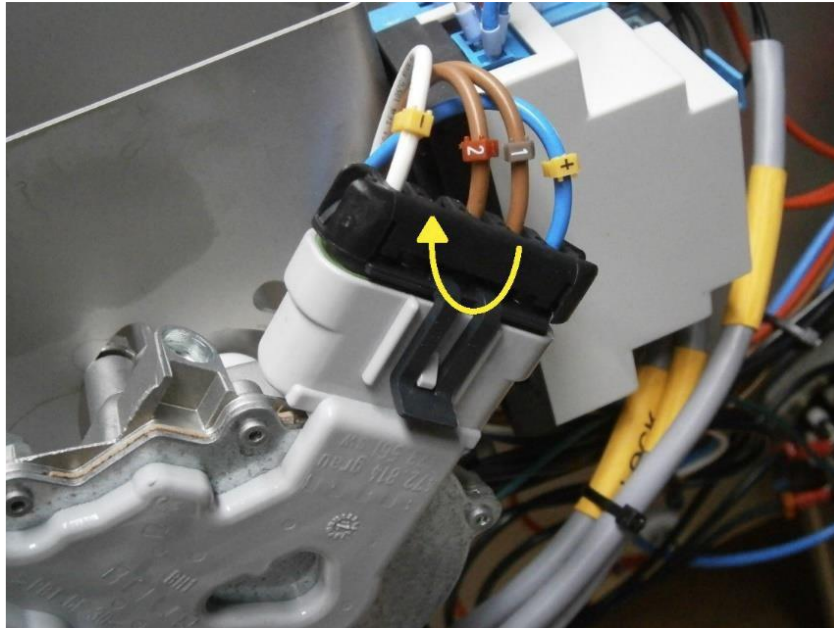
The reason is that the Z-position (Motor-stop) signal are inverted from NC to NO, to prevent the motor from stopping in random positions.

The picture below shows the wiring on the motor plug, before moving the wire:

The brown wire, located at the second terminal from the right, must be moved to second terminal from the left (which is now unused).

1. Remove the plug from the motor.
2. Remove the top of the plug by inserting a small screwdriver under the plug in both sides.
3. Release the wire plug from the motor plug, by inserting a thin screwdriver into the slot on the plug and pushing the tip of the screwdriver towards the center of the motor plug. This releases the lock and the wire can be pulled gently from the motor plug.
